# MONUMENT RECORD

Corner ID: **CICr\_V23**

## Center-West 1/16 Corner

Section 36- T07N-R01W, 2nd P.M.

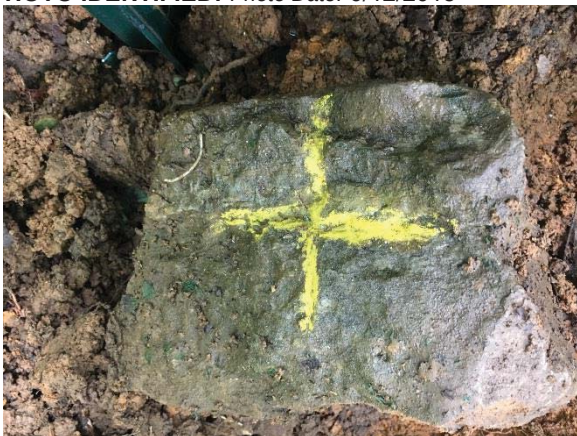
Photo Orientation & Description: CICr\_V23

**MONUMENT:** Describe monument set or found (Include material type, scribing, distance above/below grade, dimensions.)  
0.6' x 0.5' limestone with faint cut "+" found flush

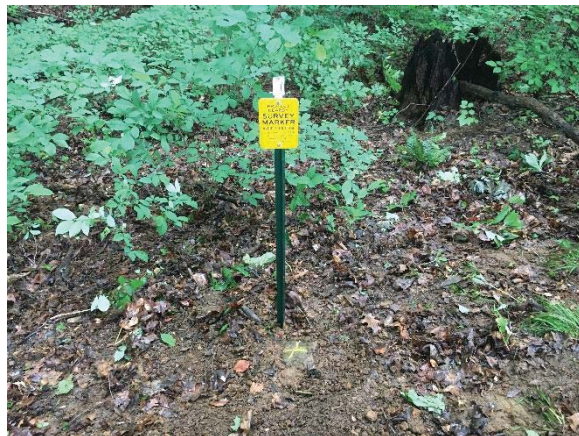
Photo Orientation & Description: Looking south at CICr\_V23

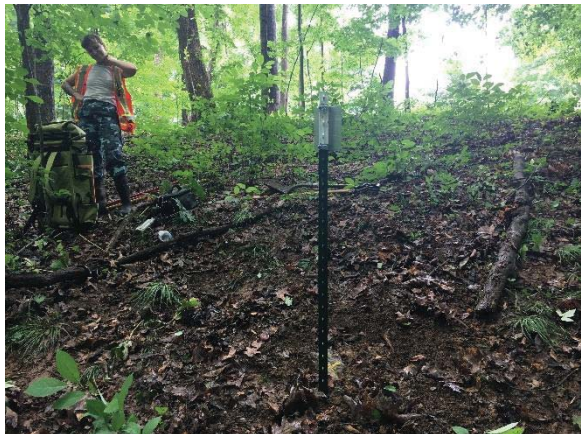
Photo Orientation & Description: Looking north at CICr\_V23

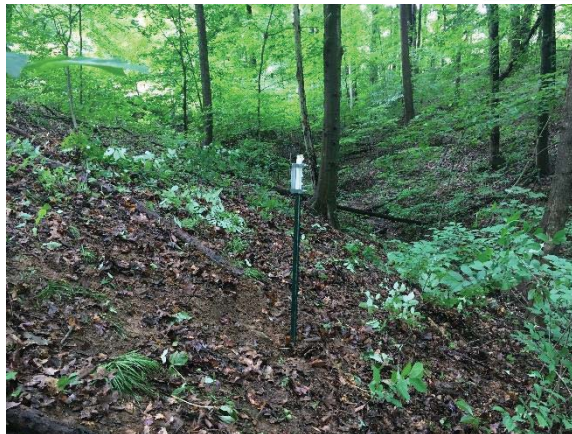
Photo Orientation & Description: Looking east at CICr\_V23
